Budget Mobile Bodyshop Ltd

COMMON LCV SILL PANEL DAMAGE REPAIR

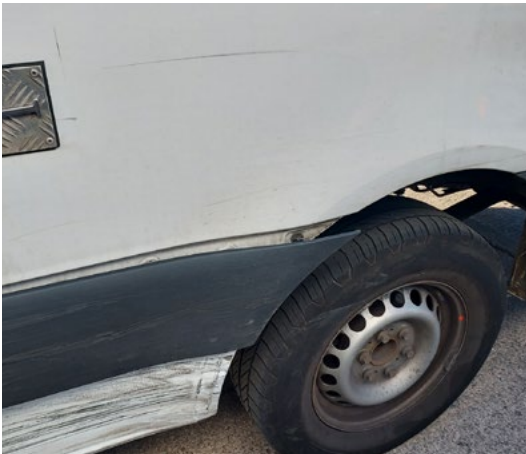
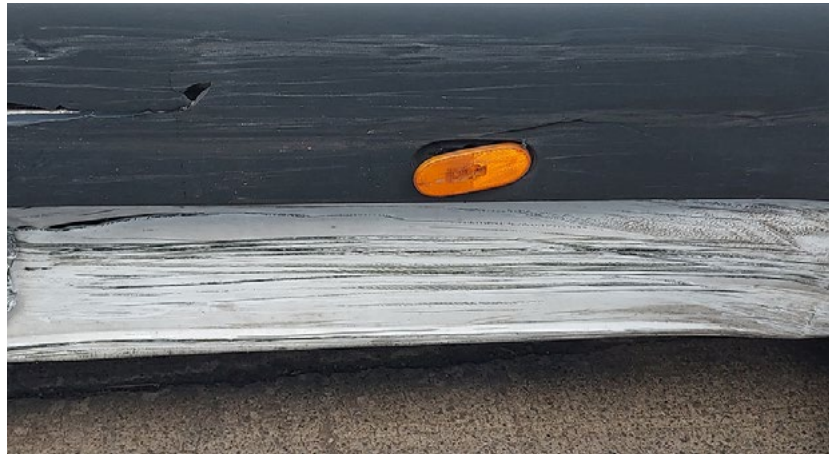
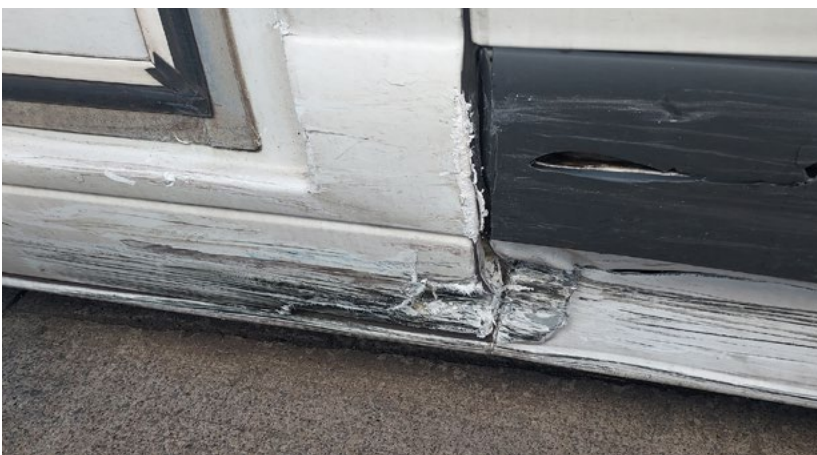
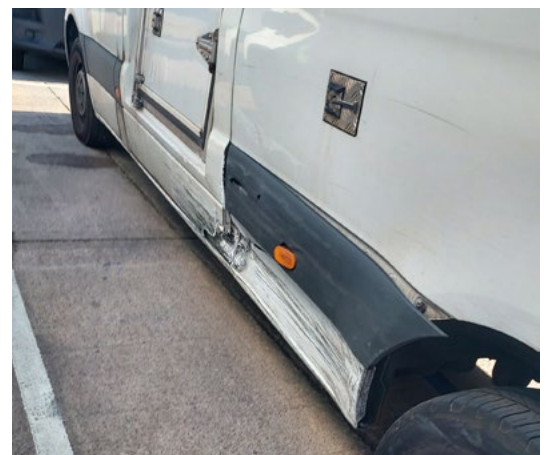
A commercial delivery operator brought their converted refrigerated van to us with typical damage that we frequently encounter in the commercial vehicle sector. The vehicle had sustained damage to the sill panel area while navigating tight delivery spaces, with the metal sill panel in front of the rear wheel requiring replacement and the fibreglass side door surround needing repair. This type of damage commonly occurs when larger vans encounter curbs, low barriers, or parked vehicles in confined spaces during urban deliveries, making it one of the most frequent repair types we handle.

The damaged metal sill panel in front of the rear wheel was completely replaced with a new component, ensuring structural integrity and proper protection.

Given that this was a converted refrigerated van with custom panels, we opted for a professional repair of the fibreglass side door surround rather than replacement, which would have been significantly more complex and expensive due to the specialised nature of the conversion.

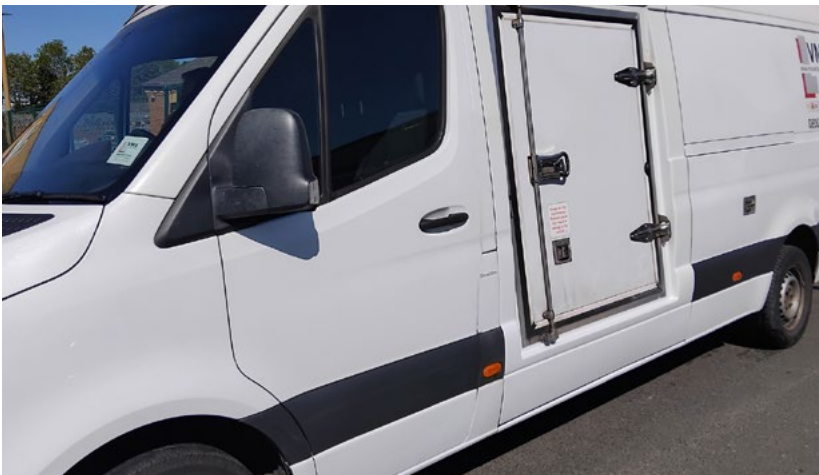
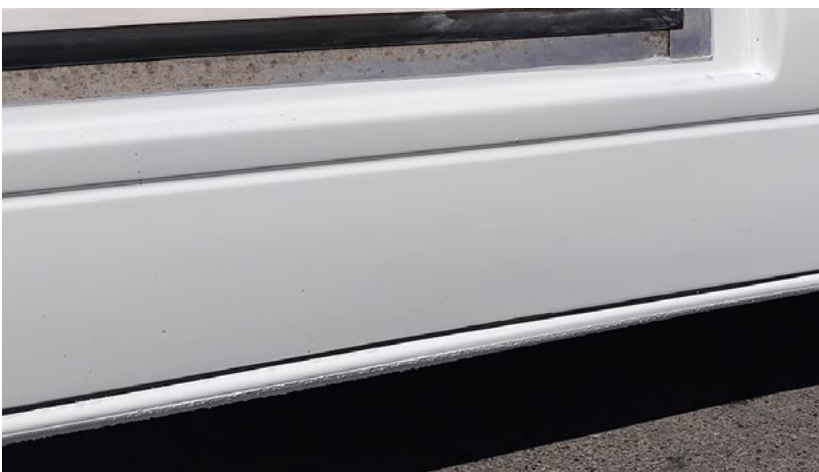
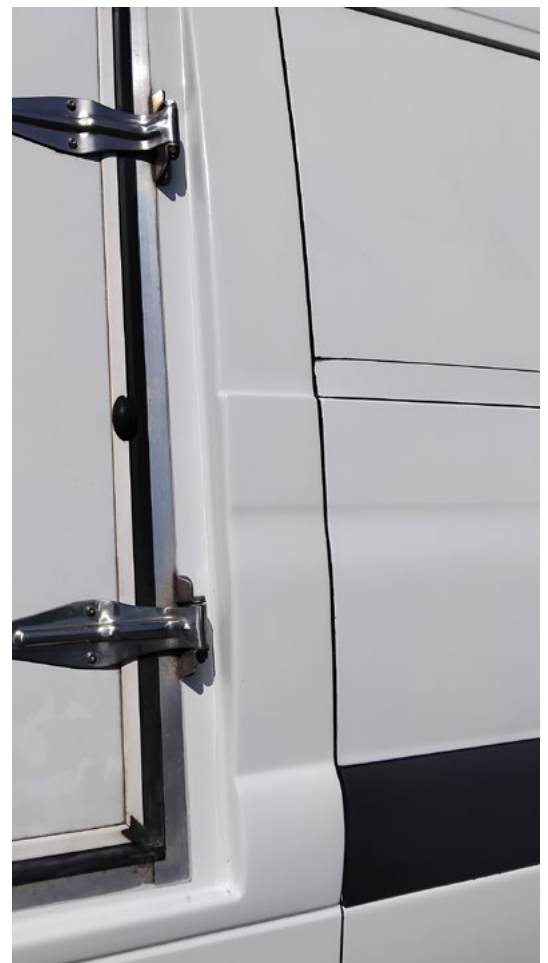
Both the metal sill panel and fibreglass side door surround were successfully restored to full operational condition within 2.5 days. The repair approach proved to be the most time-efficient and economical solution for the customer, particularly given the specialised nature of the refrigerated conversion that would have made panel replacement significantly more complex and costly.

All repaired and replaced components were finished to match the existing vehicle appearance, ensuring seamless integration with the refrigerated van's specialised bodywork.
